Impact of Water Quality Standards and Water Bodies where Meridian Operates in the Waiau Catchment

Mark James, Aquatic Environmental Sciences Ltd

Scope of evidence

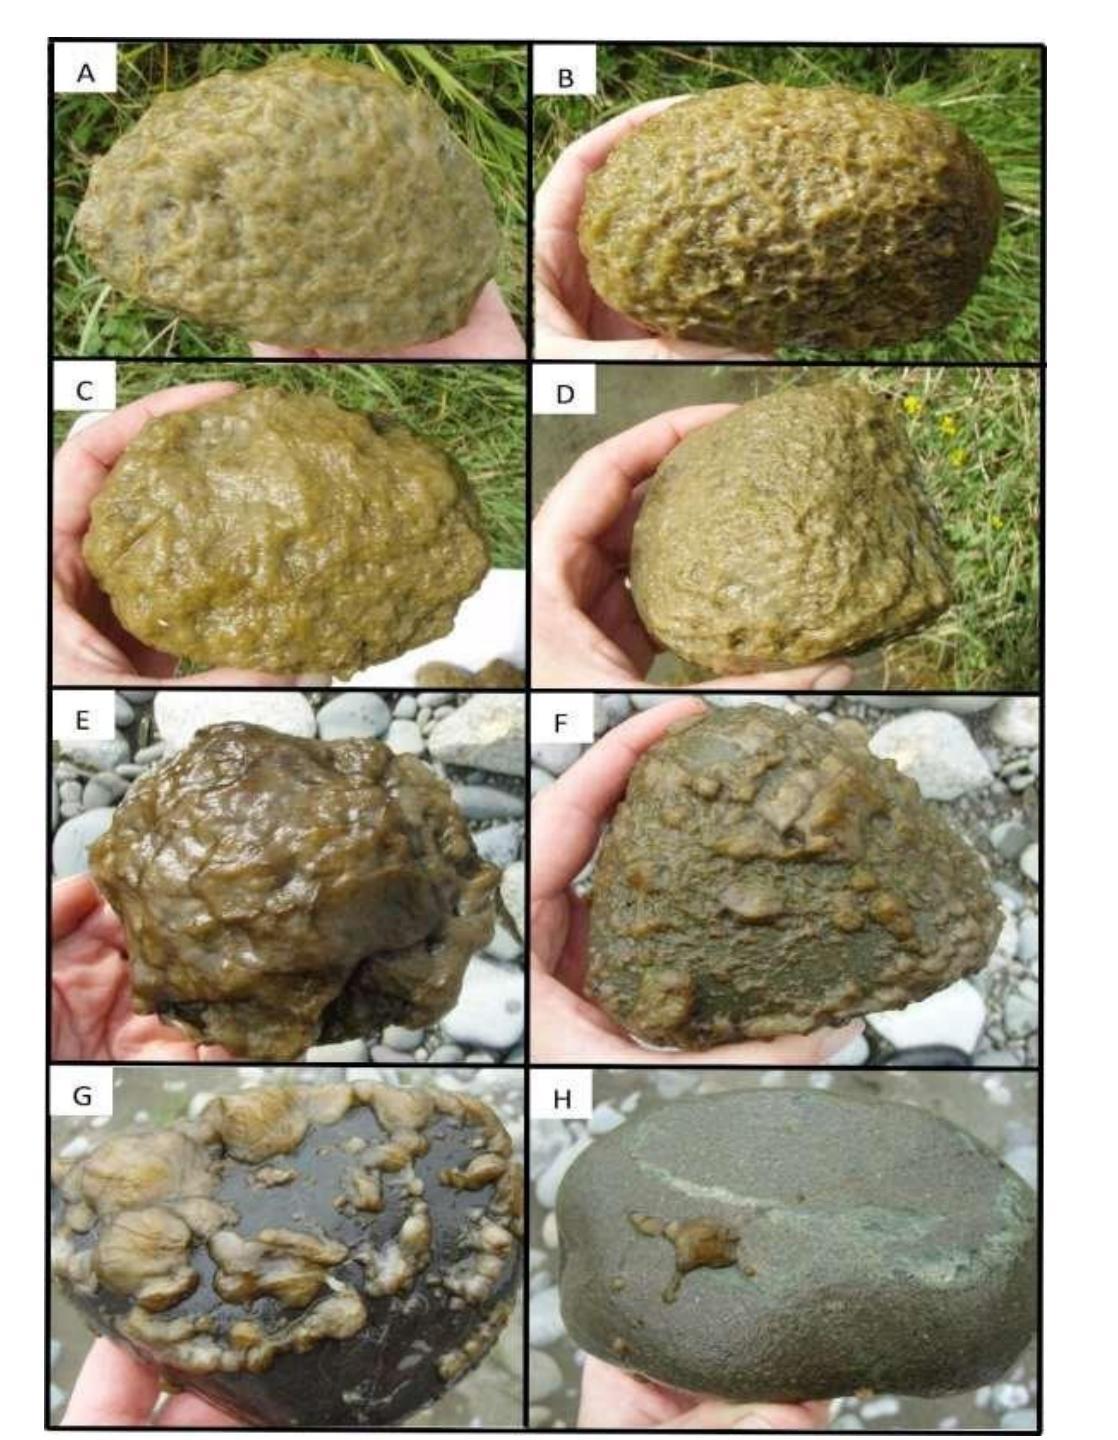
Blackmount

Redcliff

Excelsior

Station Bridge

- Waiau River a unique case because of the presence of invasive didymo – high chl a, low MCI.
- Because of didymo the Waiau River and unregulated Mararoa would regularly breach the NPS-FM and SWLP standards – unavoidable and not due to Meridian's activities.
- Only permanent and unnatural contaminants should have no change from natural state and RMZ applied.
- Potential breaches in Manapouri from diversion for which Meridian have consent and greater risk in lower Waiua River if water in Mararoa declines in quality.

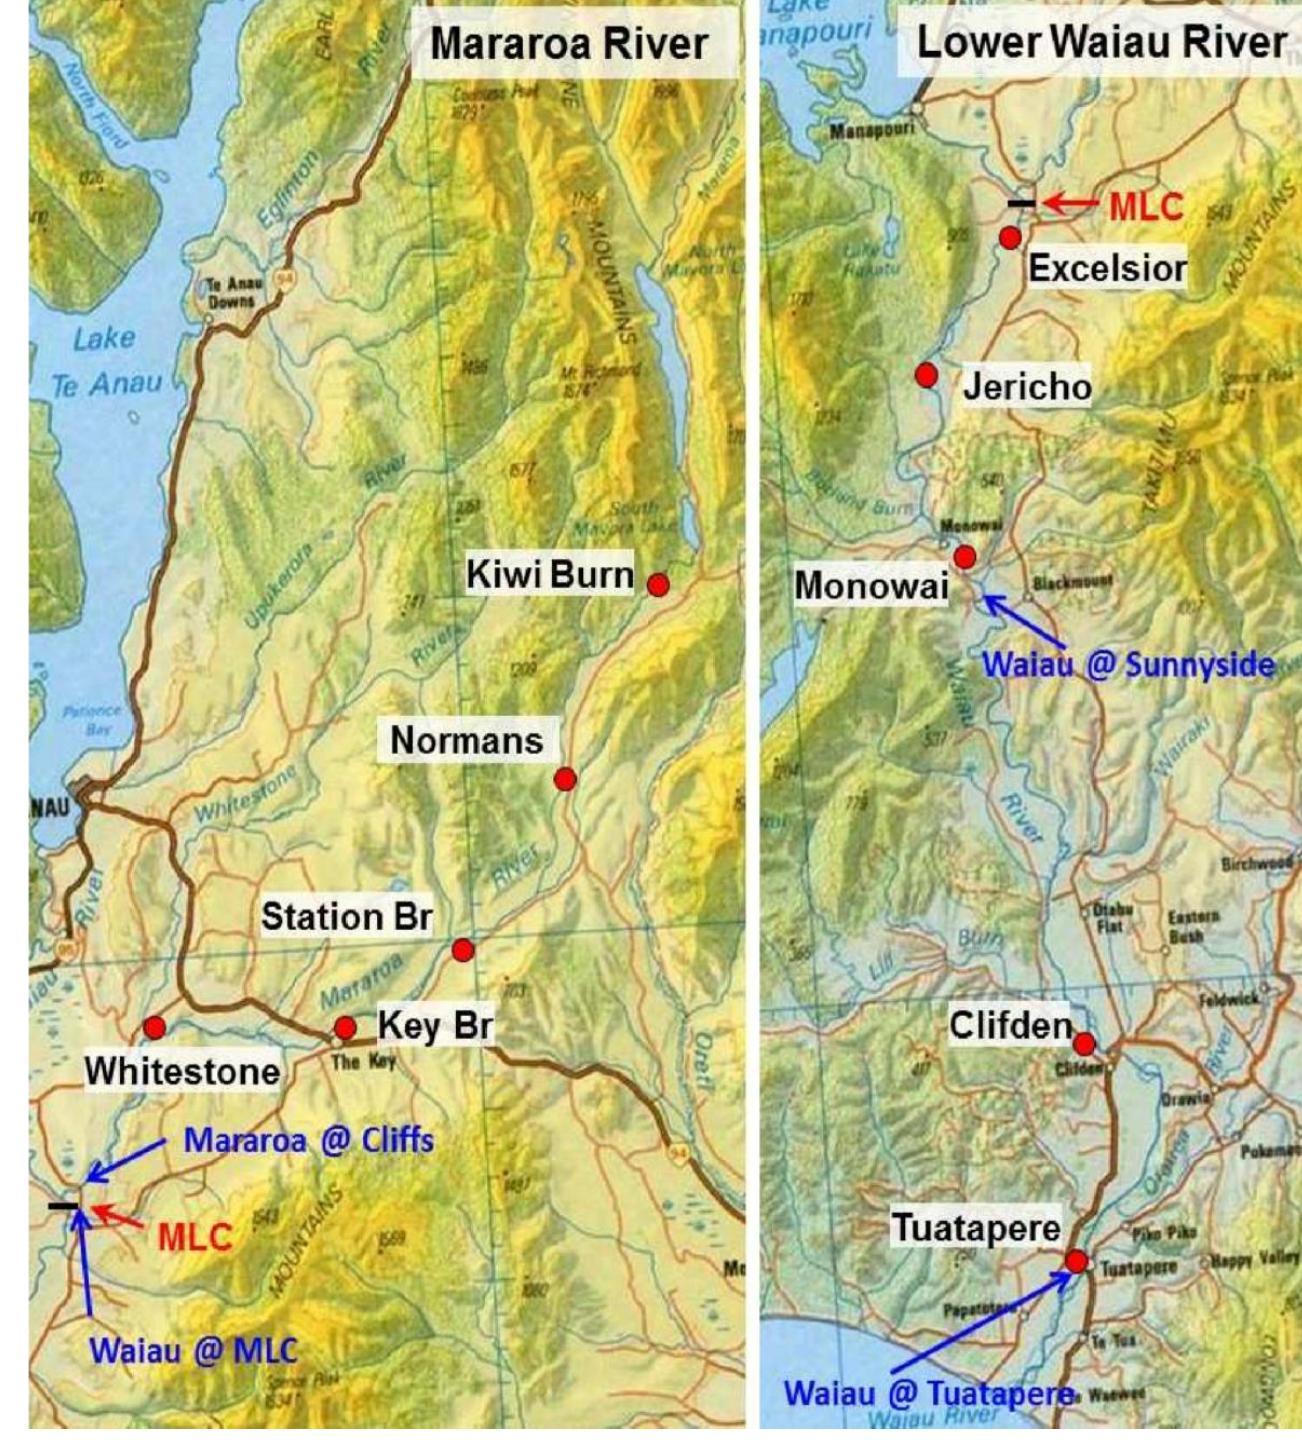
Periphyton monitoring sites up until 2015

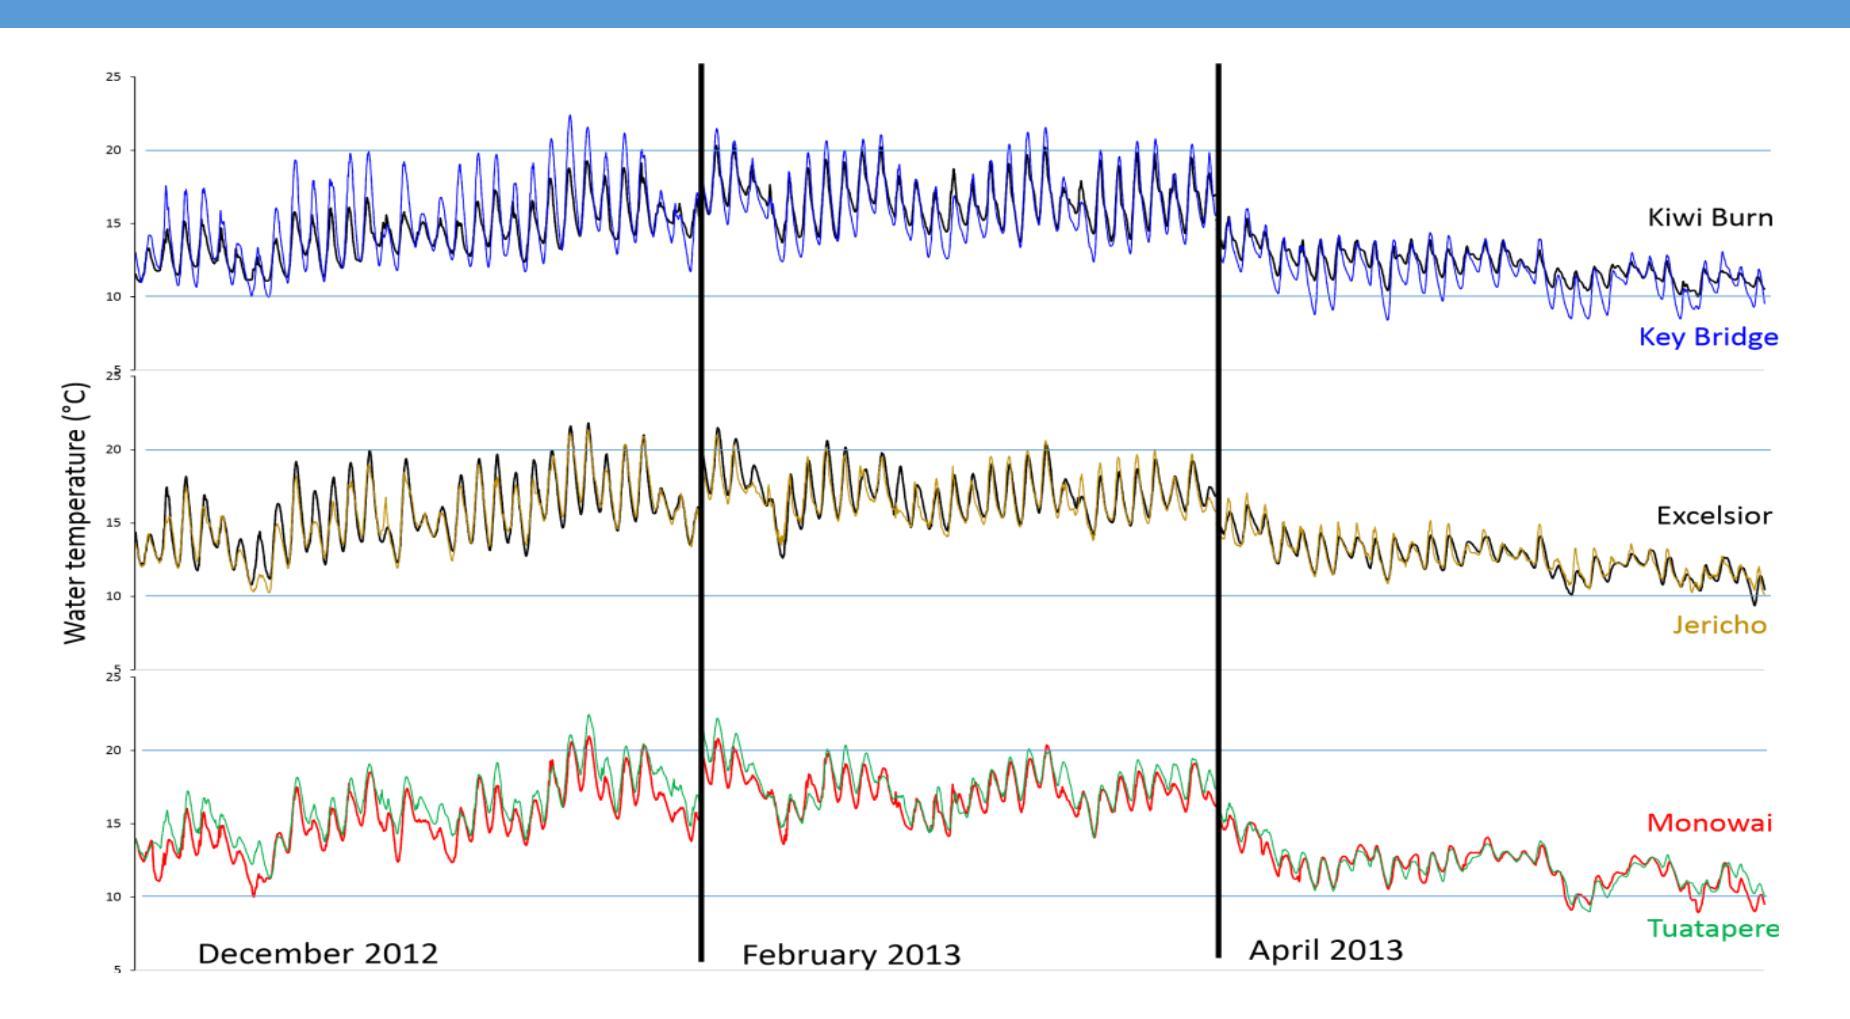
Temperature

- At least Key Bridge (Mararoa unregulated), Excelsior, Jericho and Tuatapere would breach proposed 21°C standard (Appendix E)
- Standard should be a 95th%ile or increased to 22.5 ^oC

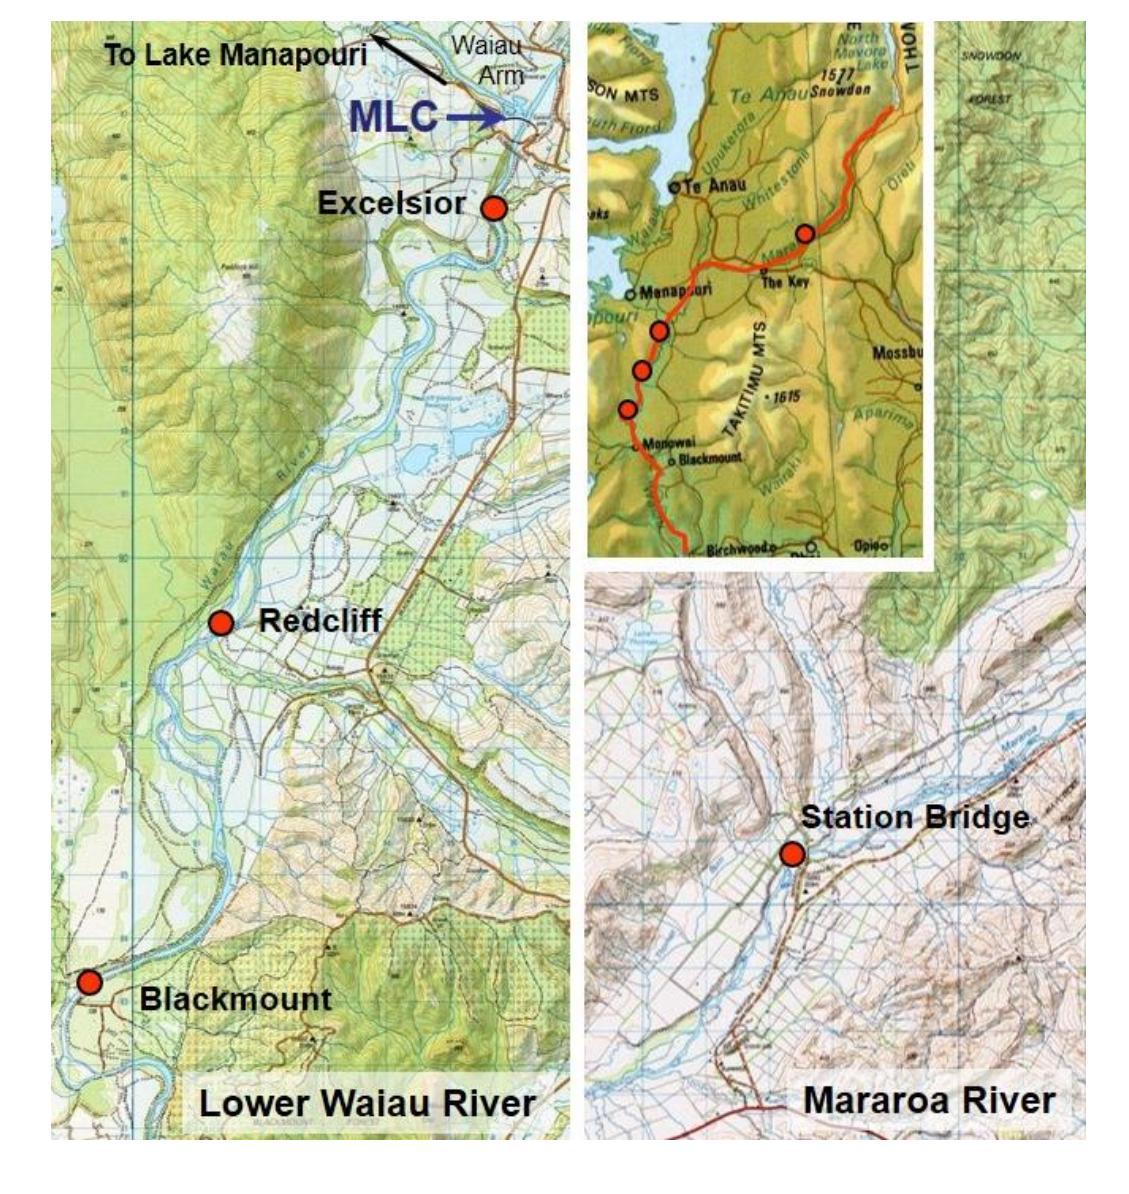
Locations of the periphyton and invertebrate annual monitoring sites on the Lower Waiau and Mararoa Rivers. MLC = Manapouri Lake Control (flow recorder location). The flow recorder for the Mararoa (Mararoa @ Cliffs) is close to the confluence of the Mararoa and Lower Waiau just upstream of the MLC

- Standard chlorophyll a shall not exceed 50 mg/m² at any time or exceed a monthly mean of 15 mg/m² (footnote averaged across full width of the stream or river)
- Didymo first discovered in 2004 in Mararoa Catchment (unregulated)
 - Found in cold, nutrient-poor waters (DRP < 2 ug/L, DIN > 10 mg/L < 400 mg/L), lake fed rivers
- Fortnightly measurements over summer/autumn on Waiau as part of comprehensive management programme – supplementary flows
- Standard of 200 mg/m² would occasionally be breached, 50 mg/m² would often be breached unachievable 15 mg/m² unable to be met, cant wade across

- Provides a useful indicator of river health
- Need to take into account didymo which changes the macroinvertebrate community to one with low MCI (below standard of 90)
- Surveys in Mararoa and lower Waiau Rivers show standard would regularly be breached and cannot be avoided (3 of 4 sites in 2015)
- Meridian releases additional high flows when water available but breaches still unavoidable
- A MCI of 90 should not apply to didymo impacted waters but noting that revised 2017 NPS-FM has requirements where MCI is under 80
